2 Erosion damage progression analysis for wind 3 turbine blade material coatings based on comparison 4 of accelerated rain erosion testing methods and 5 polymer properties

43 **Keywords:** wind turbine blades; leading edge protection; rain erosion testing; dynamic mechanical
44 analysis; CT scan; coating characterisation
45
46

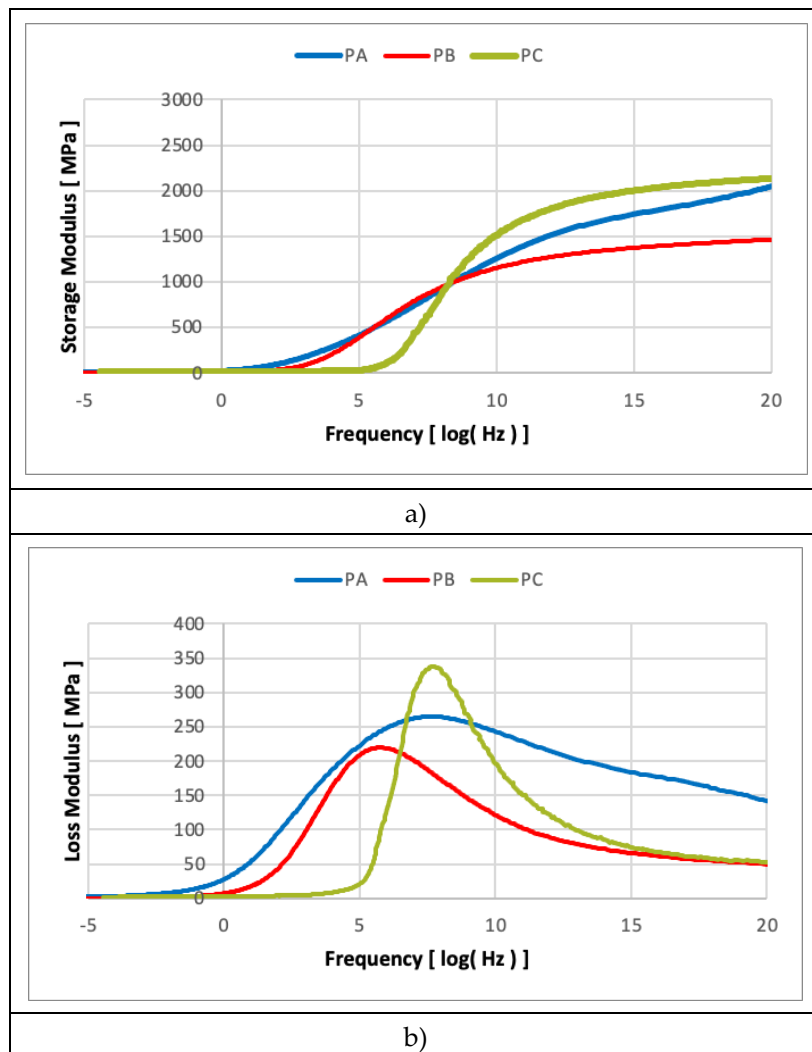
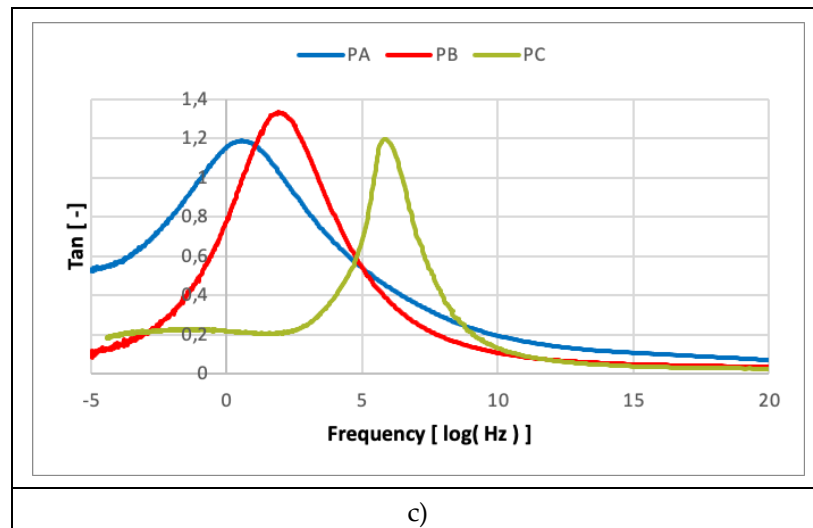
237 The results were obtained for 1 temperature sweep at 1Hz, are shown in Figure 2. At high impact
238 velocities (and therefore frequencies, range 10^4 - 10^7) the behaviour of PA and PB is similar (as can
239 be explained by the similar $\tan(\delta)$ at low temperatures) meanwhile the PC is considerably higher.
240 Relating LEE erosion data with DMA data within the scope of this research is discussed in next
241 sections.
242

The erosion durability results from the rain erosion tests align well with viscoelastic response based on DMA testing of Figure 2. The erosion behaviour of these two materials show in Figure 22 that there is a cross-over between the two materials at an impact velocity of 150m/s. At high impact velocities (and therefore frequencies in range of 10^5) the behaviour of PA and PB is similar. At lower impact velocities, PA seems to outperform PB (having a higher $\tan(\delta)$ in the lower frequency range), after which for a lower impact velocity (140m/s), PB shows the slightly better behaviour in this testing, which can be explained by the consecutive cross-over point in the frequency sweep. Both coatings PA and PB exhibits similar performance at high-speed testing ranges and alternative deductions may be done due to its lowered ability to attenuate energy at high frequencies (10^4 - 10^7) and the cross-over values in this range. While the delamination effect may contribute to erosion, current adhesion values do not correlate with viscoelastic response; further testing is needed.

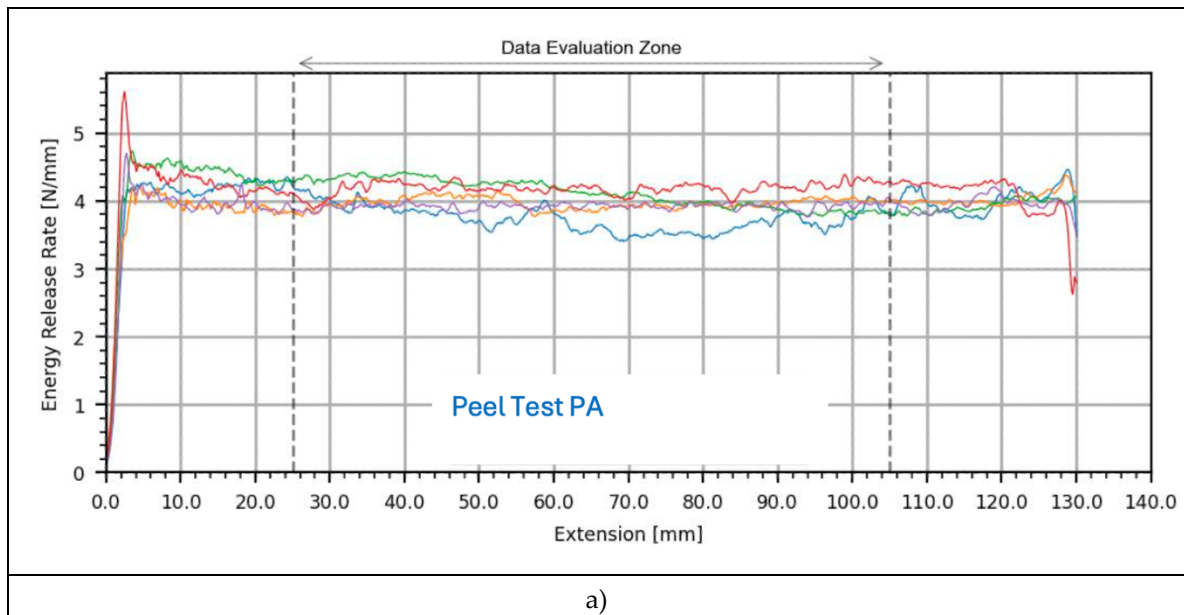
Figure 4. . Interphase adhesion peeling testing (a) Coaing PA; (b) Coaing PB; (c) Coaing PC.

283 The typical mechanical testing used in the wind turbine industry for material qualification is
284 developed in order to assess the macroscopic behaviour of the multilayer configuration adhesion. In
285 Table 1 of the previous section, pull-off strength testing of the samples shows different values. Since
286 Pa and PB have similar results and adhesive failure, the PC shows cohesive failure in which the failure
287 is in the composite laminate and hence the ability of the coating to assure the required target strength.
288 Additionally, developed peeling testing for interphase coating-filler adhesion response
289 quantification shows that PA and PB have poor values of the energy release rate and adhesive failure,
290 meanwhile PC shows partially cohesive failure noting improved interphase capabilities.

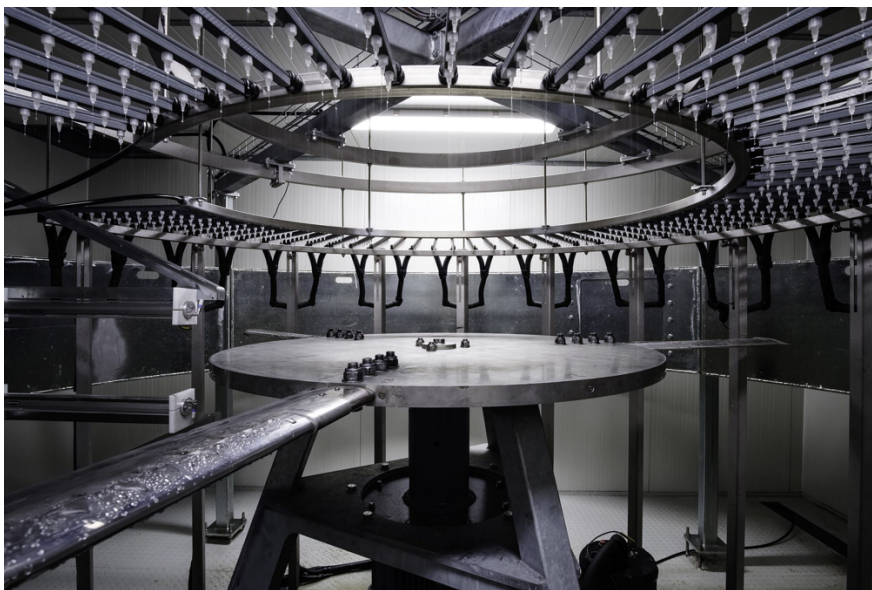
395 **Figure 13.** Rain Erosion Test developed in Aeronordic, from [32].

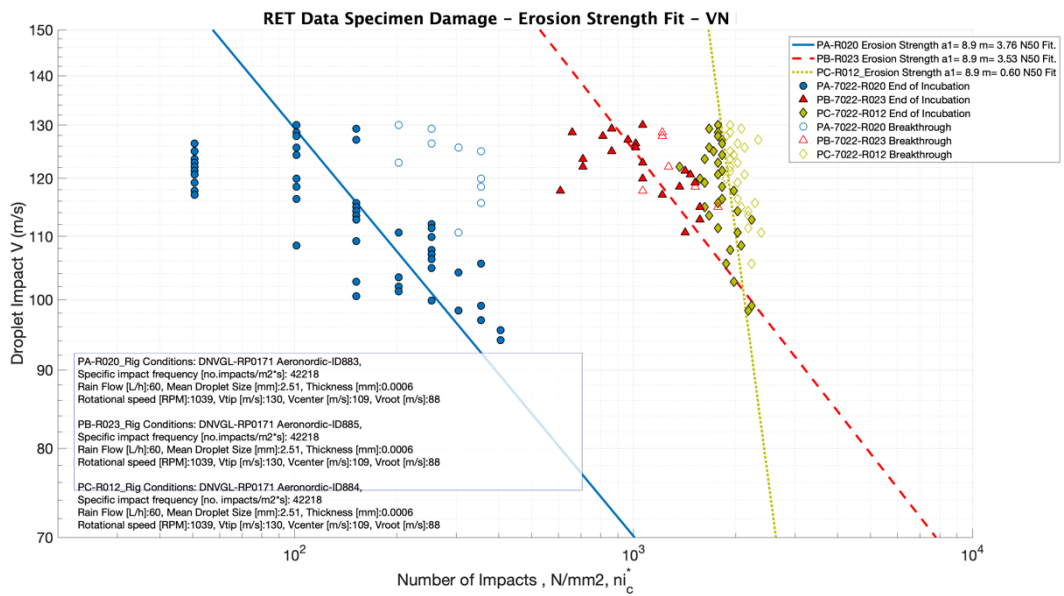
Figure 18. V-N curves of erosion strength for the three compared cases PA, PPB, and PC

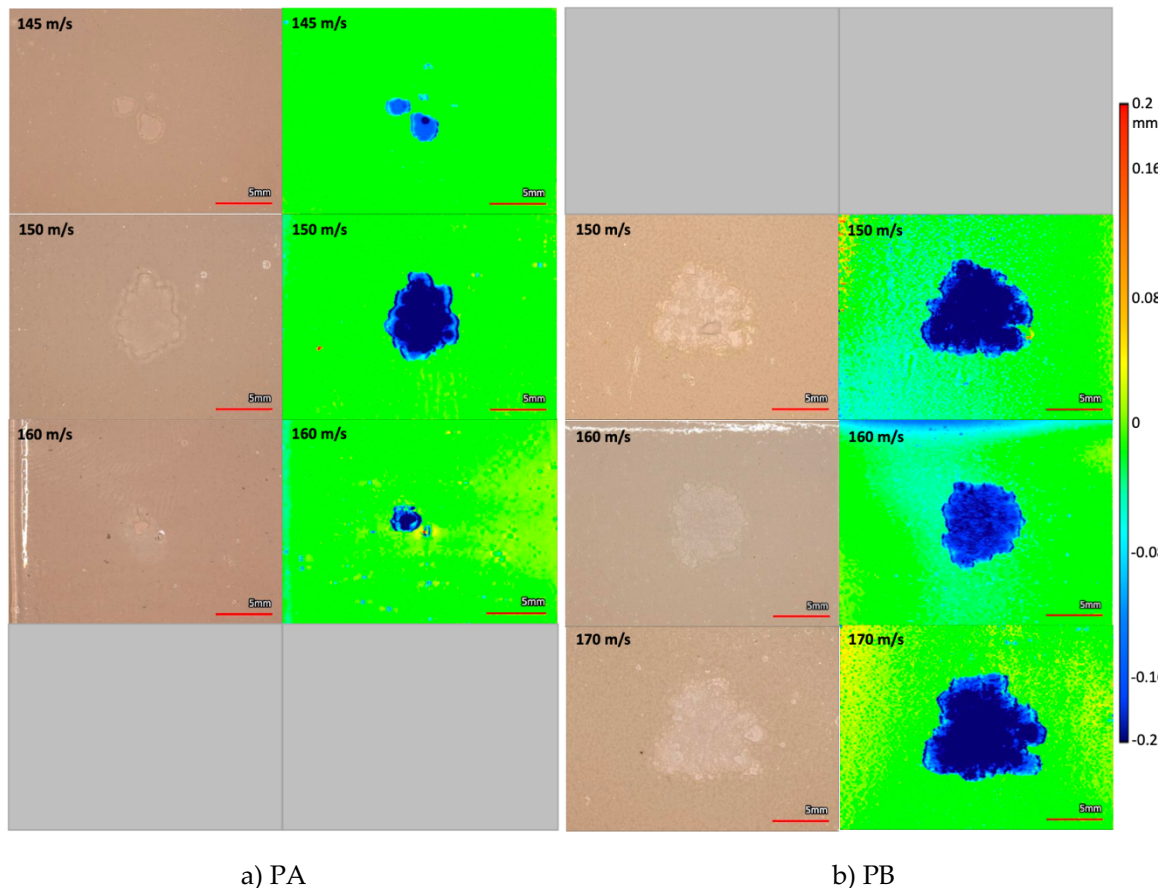
Figure 3. Optical images and height maps showing the surface damage until the breakthrough.

The samples were observed after the complete erosion. Figure 3 displays the representative surface damage until the breakthrough at selected impact velocities for PA and PB. All damages until the breakthrough are obvious since the coating layer was penetrated. The main failure mode is pitting for PA and cratering for PB. The damaged areas of PA vary from 4 to 100 mm² regardless of the impact velocity. In contrast, the damaged areas measured among the PB's test spots are more consistent, from 38 to 85 mm². In addition, there are other characteristics found as presented in Figure 4. Debonding is seen on several PA surfaces, particularly at high-impact velocities (150 and 160 m/s), and some of them appear with peeling and cracks on the coating. However, these damage characteristics are not seen in PB. Only crater-like damage is observed on the coating but further pitting and cracks on the filler occurred on some test spots. This damage underneath the coating layer is not studied in this research.
